Robert W. Goldsworthy Desalter Foulant Investigation and Performance Assessment

Water Quality Investigation Summary

October 30, 2020

Water Replenishment District of Southern California

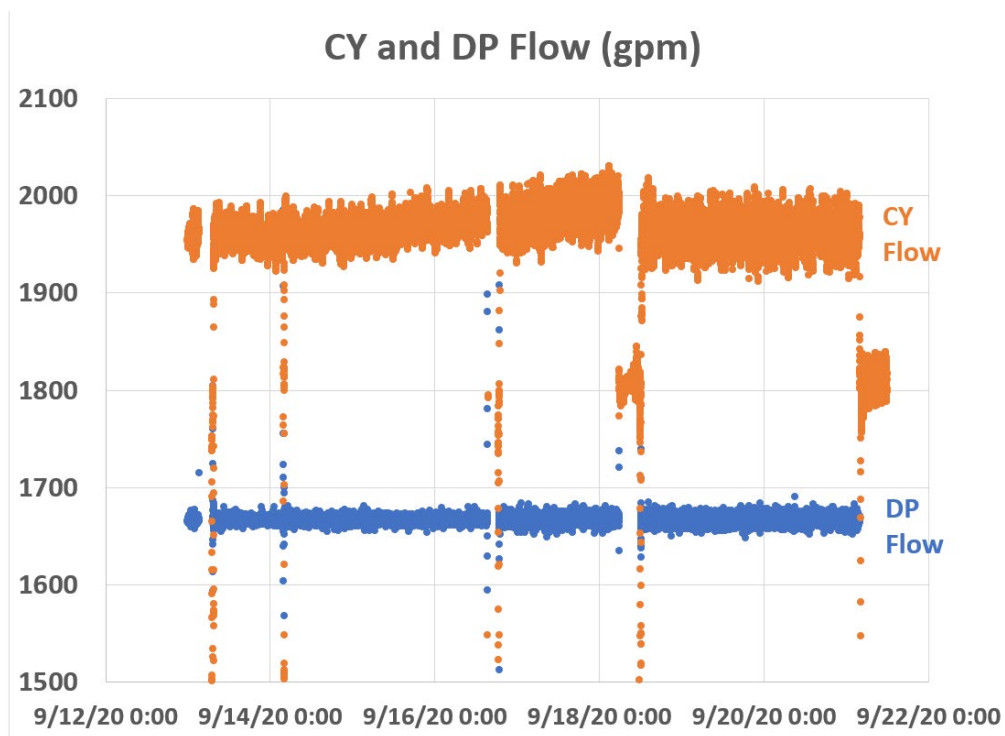
Figure 2-1. SCADA System Flow Results for Week of Testing

During the testing period, the relative fluctuations were less than 5 percent for each well. However, as show on Figure 2-1, the daily fluctuations for CYW are greater than for DPW. The City of Torrance reported (Goldsworthy Operations, pers. comm. 2020) that the CYW was rehabilitated in spring 2020, but during the video survey of the well, approximately 10 feet of silt and sand buildup was observed. Operations staff shared that the CYW pump operation tends to fluctuate more than the DPW pump, which may be caused by control programming, system hydraulics, and other factors. Further investigations would be required to determine the cause of CYW fluctuations. Fortunately, the flow rates are within the statistical allowance by INTERA/ BESST for accurate flow profiling and mass balancing for each well.

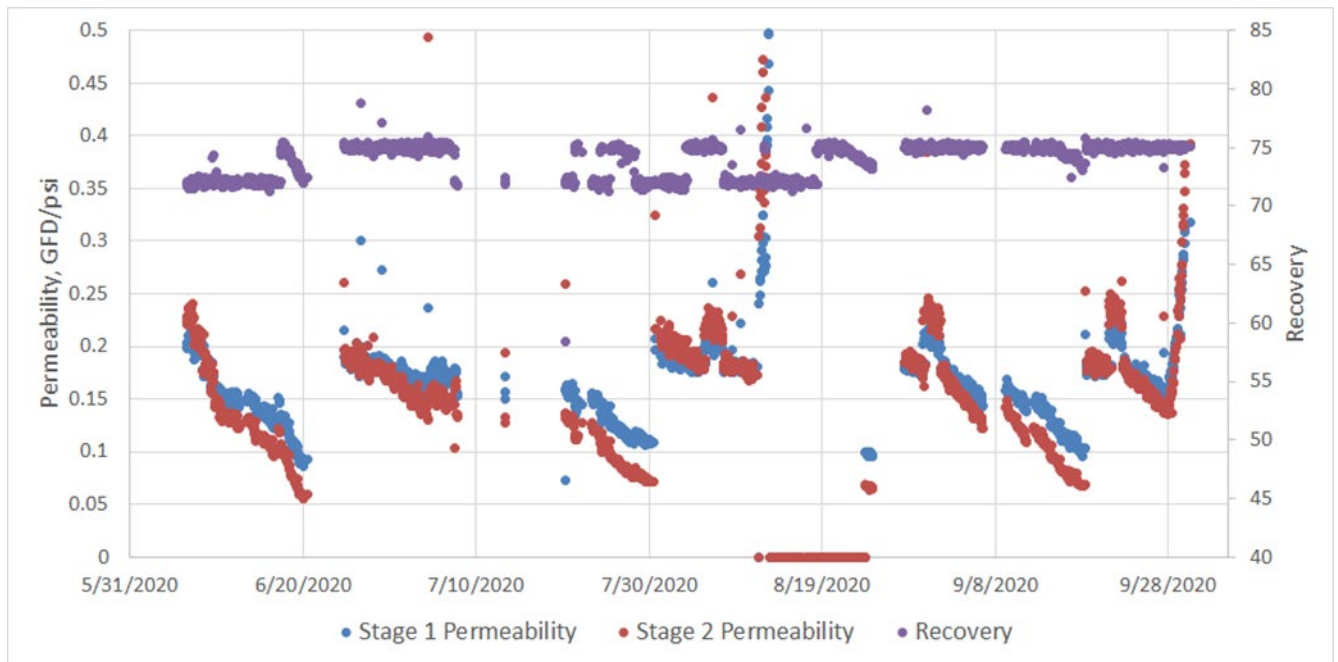
Permeability and recovery percentage for Trains 1 and 2 during the 3-month period prior to, and 1 month following, water quality sampling is trended on Figures 2-6 and 2-7. As shown, the RWGD is operating at a recovery of 70-75 percent, reduced from the 80 percent design recovery of the facility. Train 2 is operating at a Stage 1 flux of approximately 11.5 gallons per square foot per day (gfd) and Stage 2 flux of approximately 7.5 gfd, reduced from a 12-gfd design flux for both stages.

Figure 2-6. Train 1 Reverse Osmosis Performance Data during Sampling Effort Train 1 (June – October 2020)

Figure 2-7. Train 2 Reverse Osmosis Performance Data during Sampling Effort Train 2 (June – October 2020)

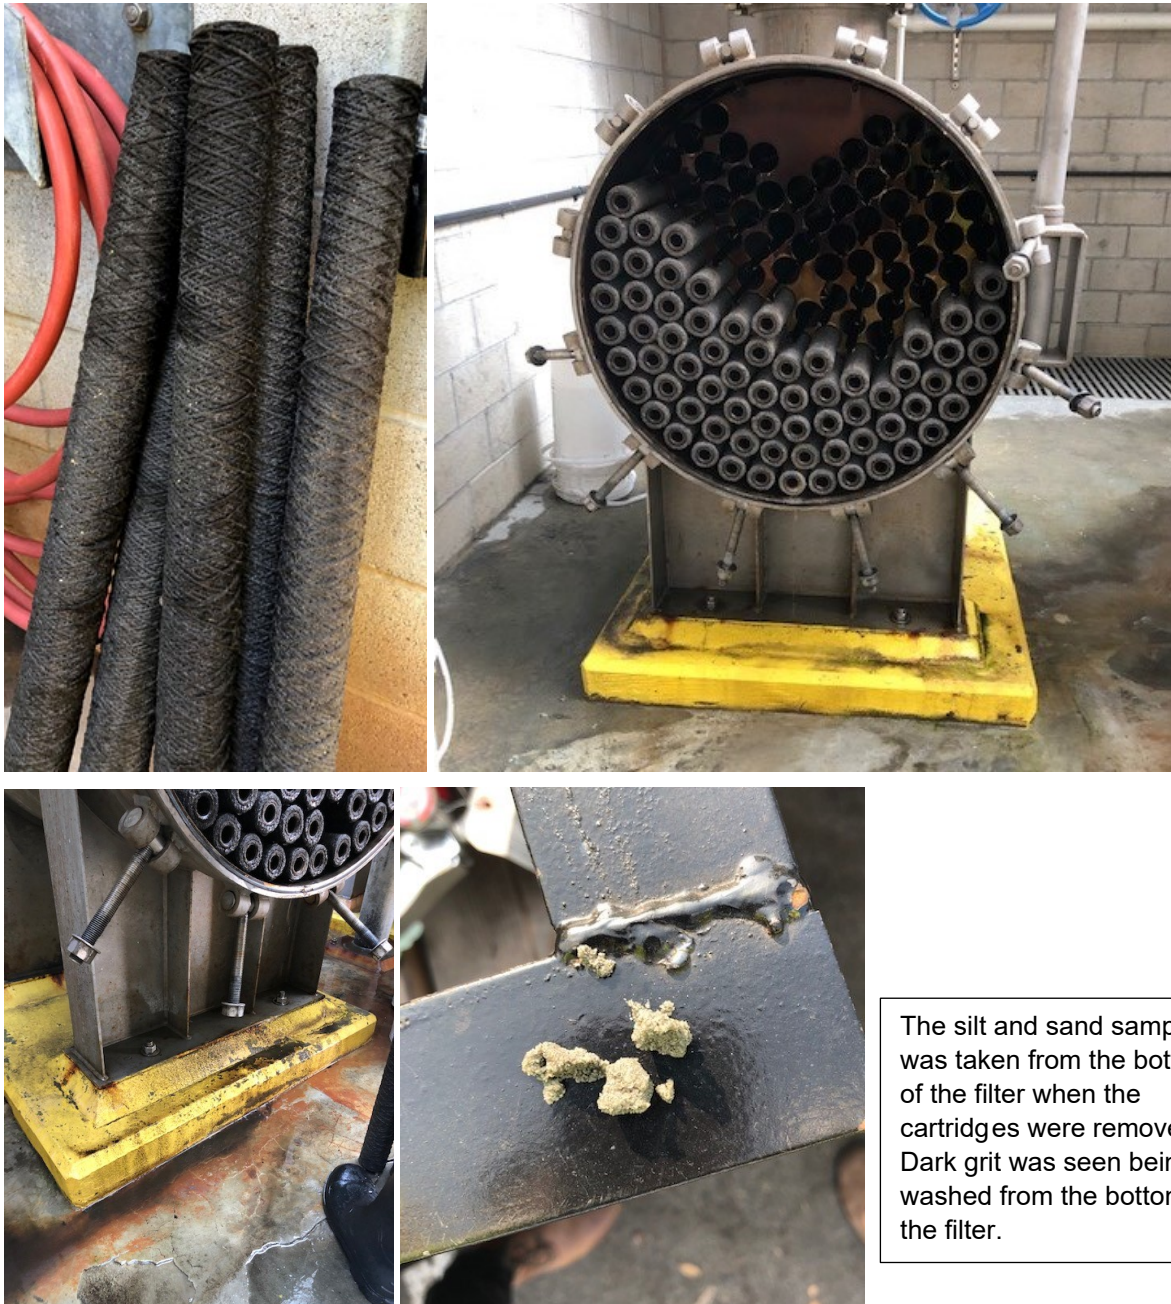
Figure 2-9. Cartridge Filters during Replacement on September 16, 2020

Cartridge filters from all three housings were replaced, and photos of the filters are shown on Figure 2-9. Fouling was observed on all filters; and a granular, silty substance was observed both on the filters and at the bottom of the housing. The cartridge filter autopsy previously conducted on August 19, 2019, by AWC indicated the deposits on the filter consisted mainly of silts and clays, iron disulfide (pyrite), and calcium carbonate. However, the color of the material deposited on the autopsied cartridge filters on Figure 2-10 differed substantially from that on Figure 2-9. The former was greenish in color, while the latter was dark brown, similar to the color on the RO elements autopsied as part of this study. Although no analyses were performed on the post-sampling filters, the color similarity suggests that organics could also be fouling the cartridge filters.

During the week of sampling, the cartridge filters experienced high differential pressure, indicating the need for replacement, which requires plant shutdown. After discussion with City of Torrance operators, WRD staff, and the Jacobs team, it was determined that filter replacement should occur after flow profiling on Wednesday, September 16 and prior to the sampling effort on Thursday, September 17, 2020, to reduce the risk of an unplanned plant shutdown during sampling, while reducing the disruption of the sampling effort.

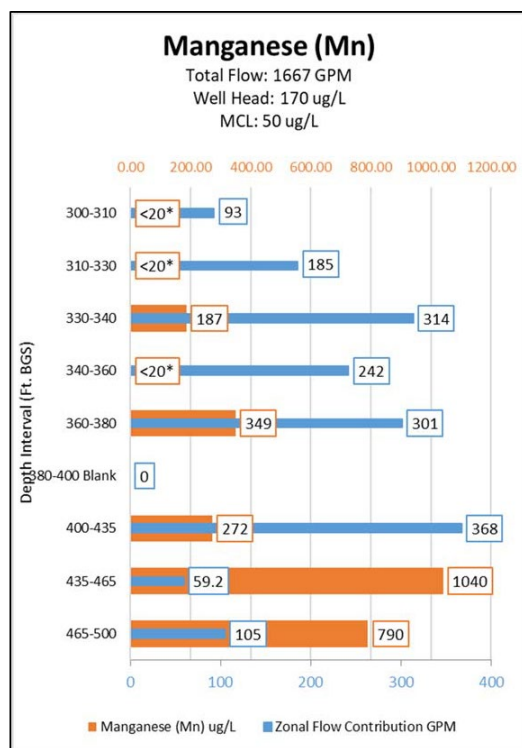
Figure 3-3. Delthorne Park Manganese Zonal Concentrations

Iron was detected at very low concentrations within the well (from ND to 29 µg/L) and only 15 µg/L at the wellhead. Although manganese was elevated at the wellhead (170 µg/L) and very high at the lowest well depth (790 µg/L per Figure 3-3), no evidence of manganese fouling was observed during the RO autopsies, consistent with anoxic conditions of the well.

Manganese is present at high concentrations in both wells, but because it wasn't observed in the membrane autopsy, it doesn't appear to be a source of RO fouling. In addition, reduced manganese would require a strong oxidant and significant reaction time (typically hours) to form a solid precipitant that would foul the RO membrane, both of which are not present at the RWGD facility. The concentration of iron is very low in the wells but does appear at low percentages in the RO foulant, possibly from particulates small enough to pass the cartridge filters or from complexation with the organics. However, it isn't suspected to be a significant source of RO fouling.

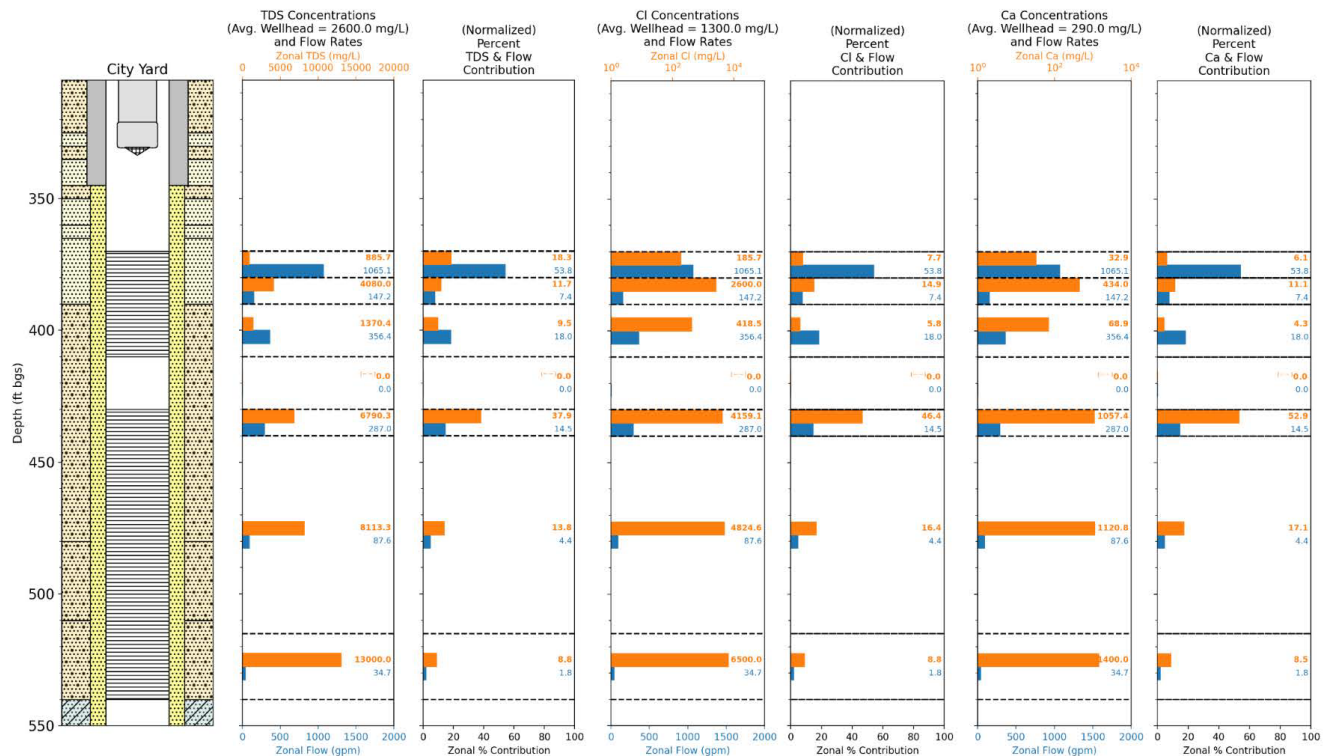
Figure 3-5. City Yard Well Total Dissolved Solids, Chloride, and Calcium Zonal Concentrations

Calcium zonal concentrations increased with aquifer depth from 33 mg/L in the top portion of the upper screen to a maximum concentration of 1,400 mg/L in the lower screen, as shown on Figure 3-5. Chloride and TDS follow the same trend. Calcium was observed as part of the RO foulant during the membrane autopsy and may be contributing to membrane fouling, as discussed in Sections 4 and 5 of this report.

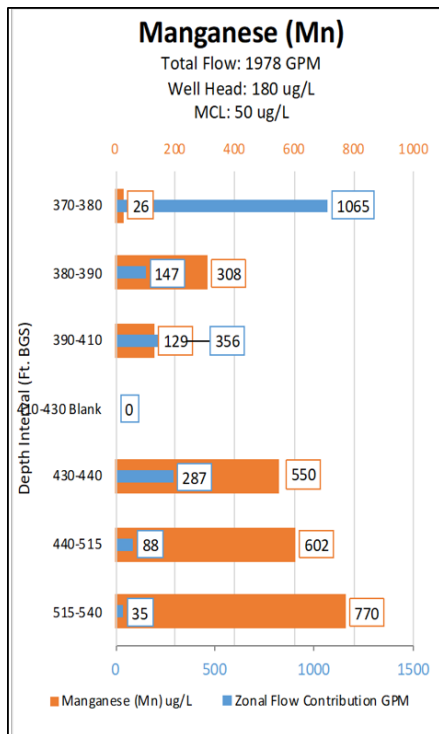
Figure 3-6. City Yard Well Manganese Zonal Concentrations

Iron was not detected at the wellhead. Although manganese concentrations were high at the wellhead (180 µg/L), and very high at some well depths, as represented by the zonal concentrations (Figure 3-6), current conditions in the wells and the system are anoxic; and manganese remained in solution, as confirmed by the lack of manganese fouling observed during the RO autopsy.

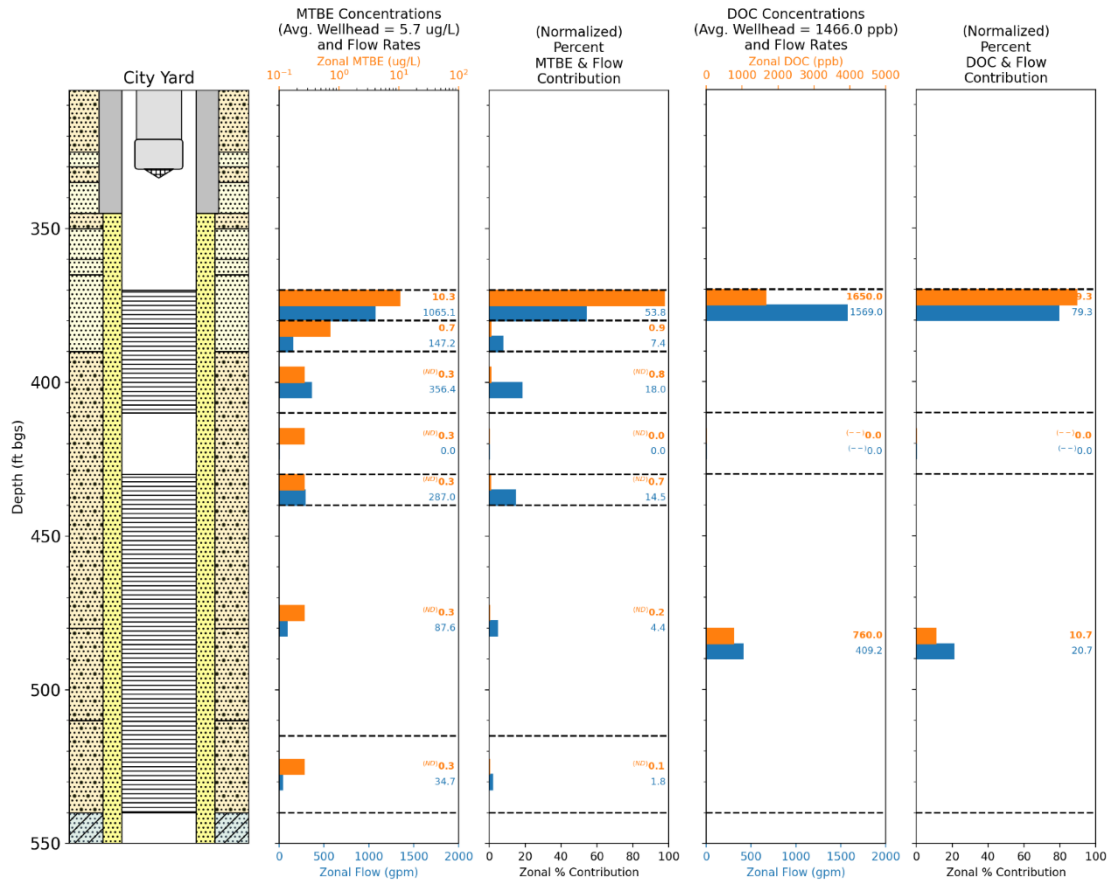
Figure 3-7. City Yard Well Methyl Tert-Butyl Ether and Dissolved Organic Carbon Zonal Concentrations

The DOC concentration at the CYW wellhead was less than at the DPW wellhead but was still significant (1.5 mg/L), with approximately 75 percent being hydrophilic DOC. DOC was less in concentration in the lower portion of the well relative to the wellhead (zonal concentration of 0.76 mg/L at 415 feet bgs), indicating that the upper portion has greater DOC levels. The lower portion sample comprised 100 percent hydrophilic NOM, significantly different than the lower portion DPW sample (approximately 60 percent hydrophilic DOC). Humic substances are the dominant hydrophilic NOM in the CYW, comprising 50 to 60 percent of hydrophilic DOC components, as shown in Table 3-5. The biopolymer concentration was very low, ranging from 2 to 4 µg/L, 0.5 percent or less of the total DOC
